INCESSANT BUILDING COLLAPSES: A CASE STUDY OF TWO FAILED BUILDINGS IN BENIN CITY, NIGERIA

Structural investigation into the failure of two church buildings in Benin City is considered in this study. Failure analysis have been performed and presented below.

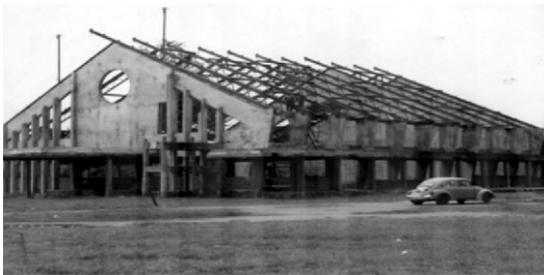
Church building I, a standard church hall for religious worship, collapsed while the building was still under construction (Figs. 3.1, 3.2 and 3.3) due to failure of the roof truss resulting from professional and

Figure 3.1: Church building under construction just before failure

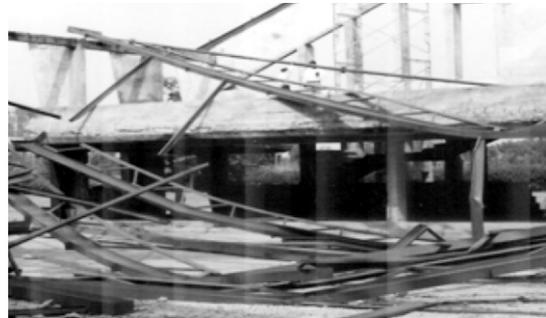
Figure 3.2: Failure of the roof truss

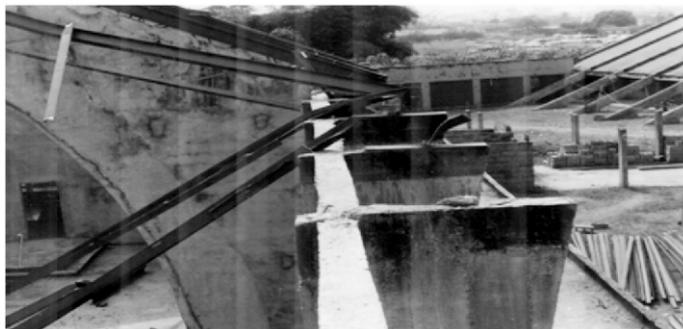
technical ineptitude of the site engineer during supervision. Principal as-built dimensions of the church building recorded on site visits revealed that the overall external dimensions of the building was 24m x 30m, the height of the roof truss alone was 6m to 13m and stood at an average height of 9.5m after installation. The roof truss structure was purely constructed in steel. It was designed as a single span truss with a high pitch angle of 30° at the midspan, each simply supported at column heads spaced at 3m centres. Steel rafters were held firmly atop three shear walls (two at the ends of the building and one at the altar) having same pitch angle as the truss. U-shaped rag bolts were designed to be used in holding down the steel roof truss to the top of each column.

Figure 3.3: Top of column after failure

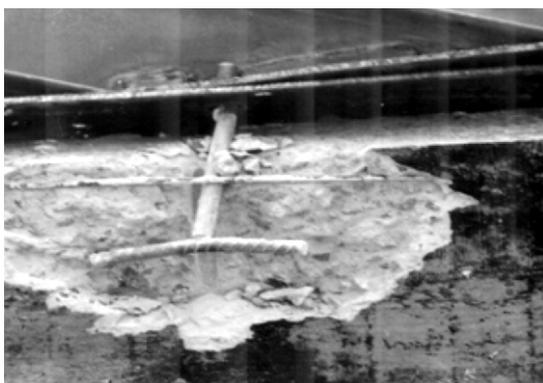
Figure 3.4: *Rag-bolt failure from the top of the column*

(Fig. 3.4). Rag bolts should have been positioned orthogonal to the longer face of the column to provide the required resistance to hold the truss down and transfer load through the load path down to the base.

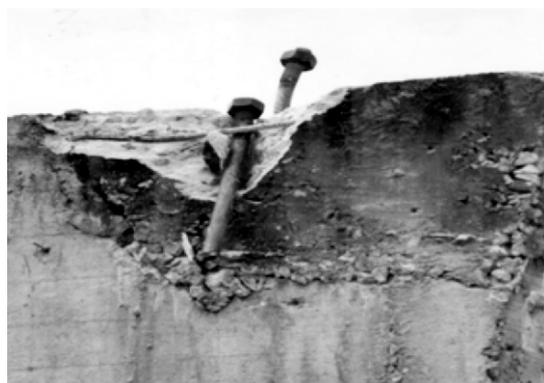
- Concrete cast atop the previously cast columns was shallow. From Fig. 3.5 the two bolts shown after failure pulled out from the welded T-portion which was still embedded in concrete.
 - Concrete cast around the rag bolts where very poorly mixed and inadequately compacted; resulting in relatively weak concrete (Fig. 3.4).
3. While the steel roof truss was mounted and fixed to the rag bolts, horizontal reaction from the truss on the bolts in Fig. 3.5 caused a large displacement resulting in translational movement of the bolts out of the shallow concrete hence the failure of the roof.

Figure 3.5: *Rag-bolt pull out from a very poorly compacted concrete.*

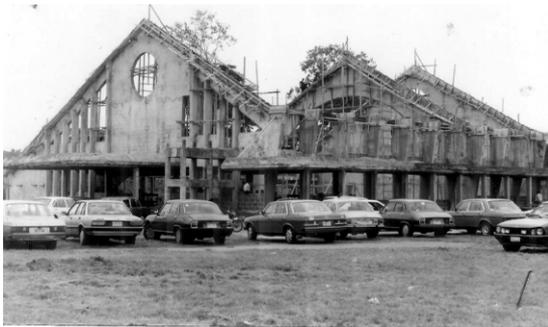
- The truss support system was reconstructed using properly well-compacted and properly mixed concrete cast to the correct depth as originally designed by the structural engineer (Fig. 3.6).
- U-bar rag bolts formed by bending rather than welding were properly installed by placing the bent bar orthogonal to the face of longer side of the column and held in position with longitudinal bars passing inside the U-bolts, top and bottom (Fig. 3.7).
- The steel roof truss was reconstructed and remounted on the column heads based on the original design and detail provided by the structural engineer. Supervision was done by a qualified and experienced site engineer (Fig. 3.8).

Figure 3.6: *Re-construction of the truss support system*

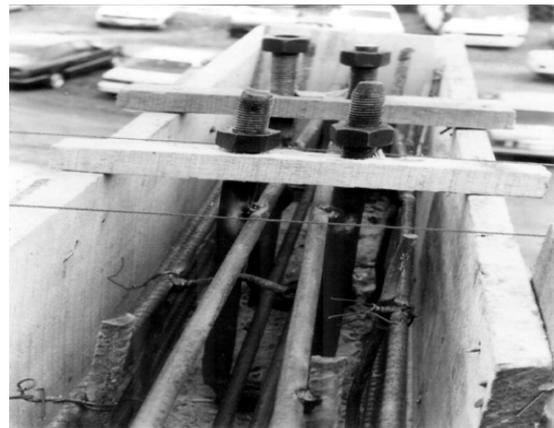
Figure 3.7: *Correct installation of the rag-bolt*

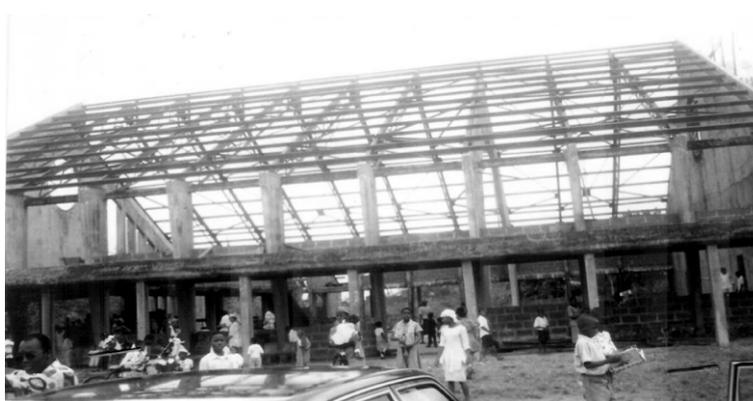
Figure 3.8: *Re-constructed truss*

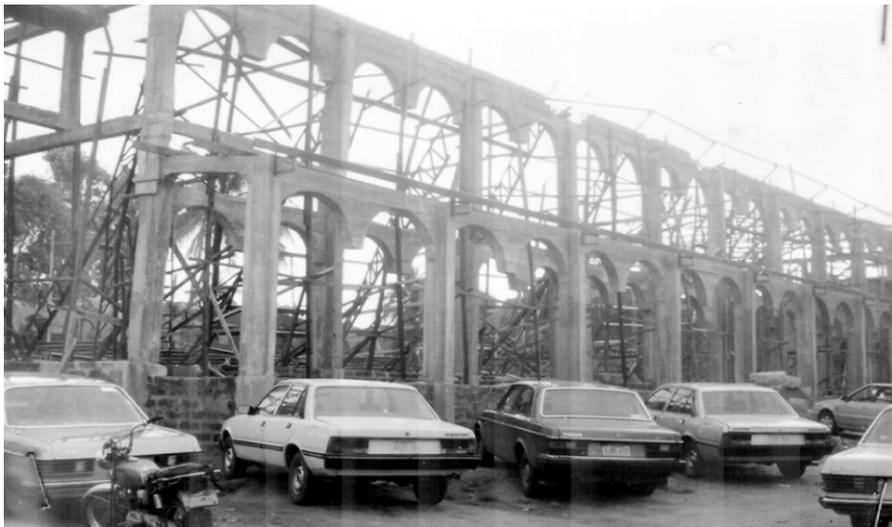
Church building II, a standard church hall for religious worship, collapsed while the building was still under construction due to failure of the roof truss resulting from inadequate design and poor construction supervision (Fig. 3.9). Weather was fair, just slight wind and rain. Principal as-built dimensions of the church building recorded on site visits revealed that the overall external dimensions of the building was 25m x 33m, the depth of the roof truss alone was 600mm and stood at a height of 9m after installation. The average height of

Figure 3.9: *General view of the church building before failure.*

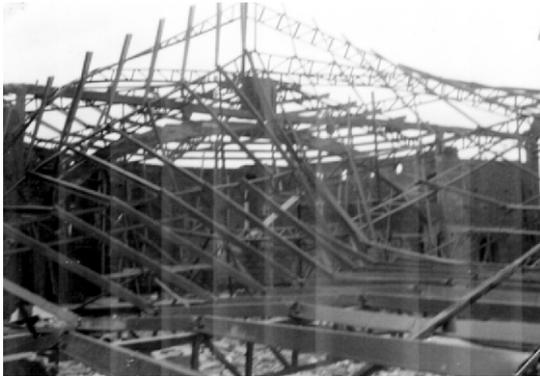
2. Inadequate truss member sizes, depth, pitch angle and section were fabricated by the contractor to span 25m. Overall depth of truss was 600mm with 75 x 75 x 6mm top angle bars as top and bottom chords and 50 x 50 x 4mm angle bars as diagonal and vertical

- bracings (Fig.3.10).
3. Roof slope is inadequate (13.50) compared to span resulting in sagging/ twisting of the trusses.
 4. Concrete used to cast the beams and columns was poorly mixed and compacted resulting in weak concrete (Fig. 3.11 and Fig. 3.12). (Could the strength of this concrete be obtained?)
 5. Short lap lengths were used for the bars in column and the position of the lap was 400mm above the beam instead of

Figure 3.10: Failure of the trusses

5. Truss was reconstructed to the depth and member section sizes provided in the design done by the structural engineer (what was the grade of steel used, provide some of these kind of information).

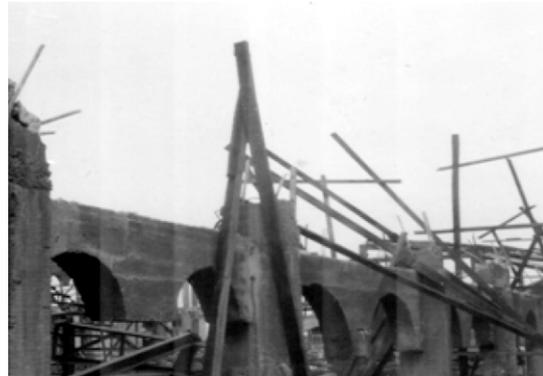
Figure 3.11: Failure of the side columns

3. Failed column was demolished completely and reconstructed by ensuring that concrete of the right grade and quality was properly mixed and well compacted. Also, appropriate lap length and lap position for reinforcing bars was used.

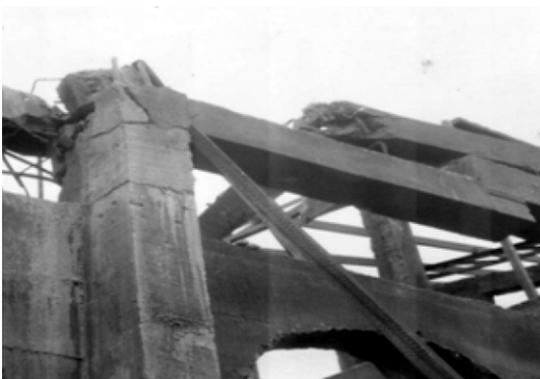
Figure 3.12: Failure of other columns and beams

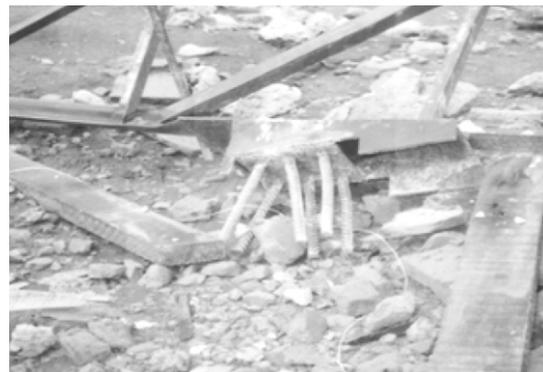
6. The rag-bolts were crudely formulated and fabricated (Fig. 3.13).
7. Rag-bolts were inappropriately embedded in the concrete column and as a result, the column reaction transferred to the rag bolts was not effective in providing adequate resistance to the end support reaction from the truss and wind forces, hence the roof truss collapsed.

Figure 3.13: View of rag-bolt after failure

4. The correct size of rag-bolts was designed by the structural engineer and placed properly, perpendicular to the face of the column's biggest cross-sectional dimension.
